# Chapter 14
# Dynamic Properties by OMA and Modal Updating of a Mayan Temple

**T. Nunez and C. E. Ventura**

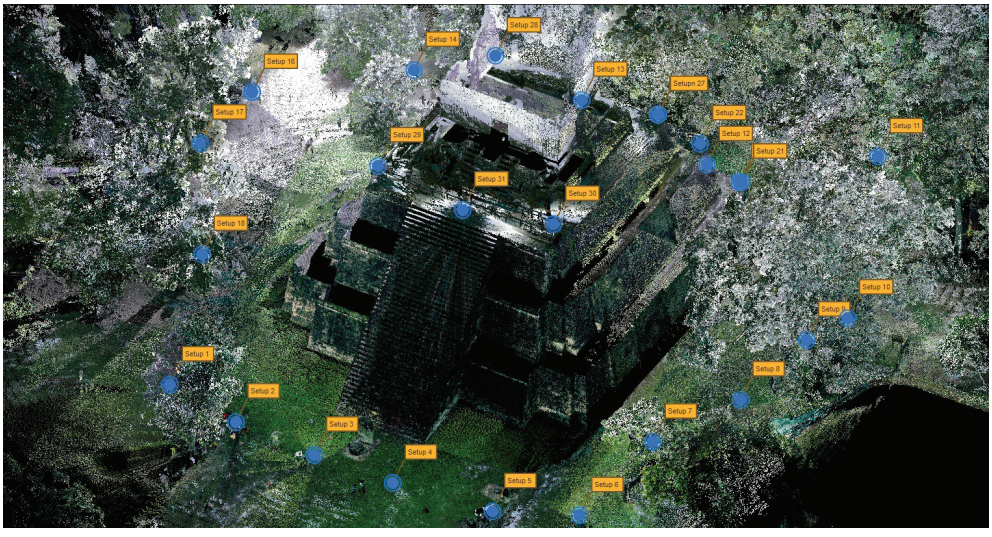
A laser scanning survey was conducted around the pyramid to produce a high-resolution 3D point-cloud model. Thirty-one scan positions captured up to 360,000 points per second, accurately recording the structure's geometry and external features (Figure 3). The processed data provided a precise 3D reference for structural and geometric analysis, including assessments

**Fig. 3** Laser Scanner Positions during survey

of verticality and differential settlements. These measurements revealed potential tilting and foundation movements, offering key insights into the pyramid's current condition and long-term stability.
