Chapter 15
The Great Train Disaster of 2025: Isolating Sensitive Equipment from Rail-Induced Vibration

This paper describes a project on a major commuter rail line in the United States where several Bonds were failing repeatedly at a discrete number of locations on the system. Extensive measurements and investigation determined that that a combination of locally poor track conditions and inadequately designed isolation systems were responsible. Several new isolation systems were considered, as well as track quality improvements in order to eliminate the repeated failures that were causing significant issues with the operations of the rail network.

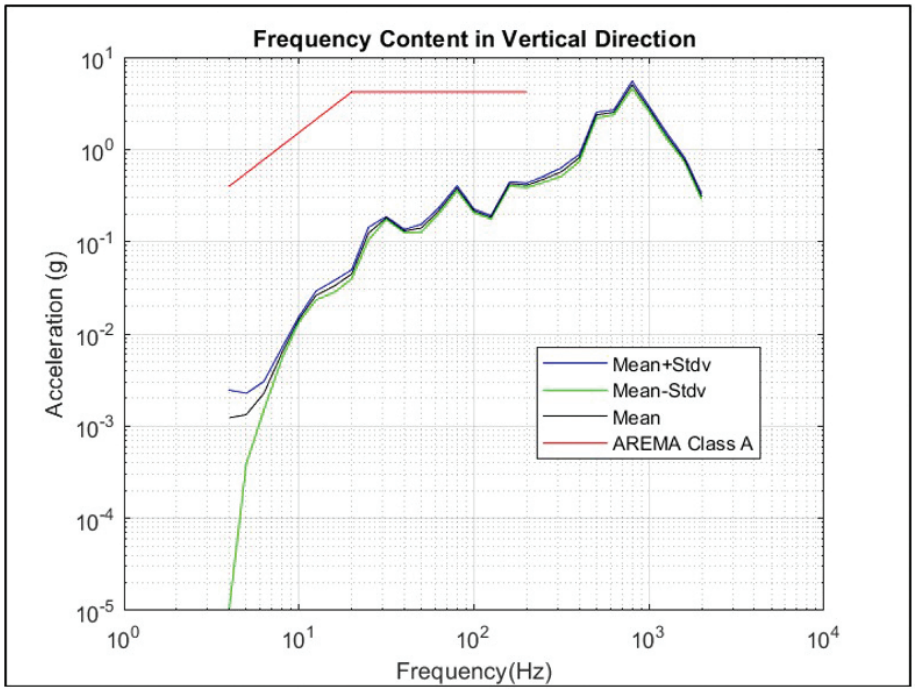
Fig. 3 Frequency Content of the Measured Vertical Vibration Data on the Bond

- Consistently high-magnitude energy content at high frequencies between 700 Hz and 1000 Hz were measured. See Figure 3 for one-third frequency content in the vertical direction atop the Bond. These high magnitude forces at these high frequencies are generated by the wheel-rail interaction, particularly when the trains are running at high speed. It is noted that significant rail corrugation was observed at the failure location. The existence of rail corrugation and high speed of the train pass-bys could be attributed to these high vibration levels at these frequencies.

- It should be noted that measurements were taken at frequencies considerably higher than the 200 Hz upper limit of the AREMA criteria. As can be seen in Figure 3, the levels of the accelerations above 200 Hz are an order of magnitude higher than those below 200 Hz, which points to a potential deficiency in the criteria limits used by AREMA.

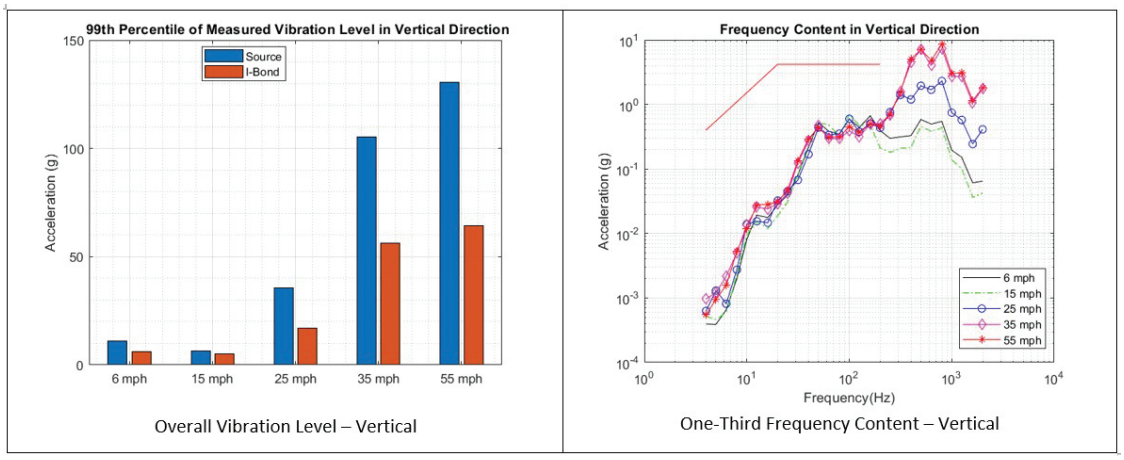
Fig. 4 Vibration as a Function of Train Speed

- The overall vertical vibration levels at different speed limits are presented in Figure 4. The corresponding one-third octave frequencies are also presented in Figure 4.

- As expected, the vibration levels increased with the speed of the train pass-by. The highest vibration levels were observed due to train pass-by at 55 mph.

- Up to 200 Hz, the energy contents are similar, irrespective of train speed, indicating that the vibration response of the Bonds is governed by the substructure stiffness at these frequencies. Above 200 Hz, the energy contents increased with the speed of the train. As noted in the initial testing, the energy contents at the high frequencies are related to wheel-rail interaction at speeds 35 mph and above. The high amplitudes of vibration at these frequencies are directly related to existing rail corrugation at the subject site.

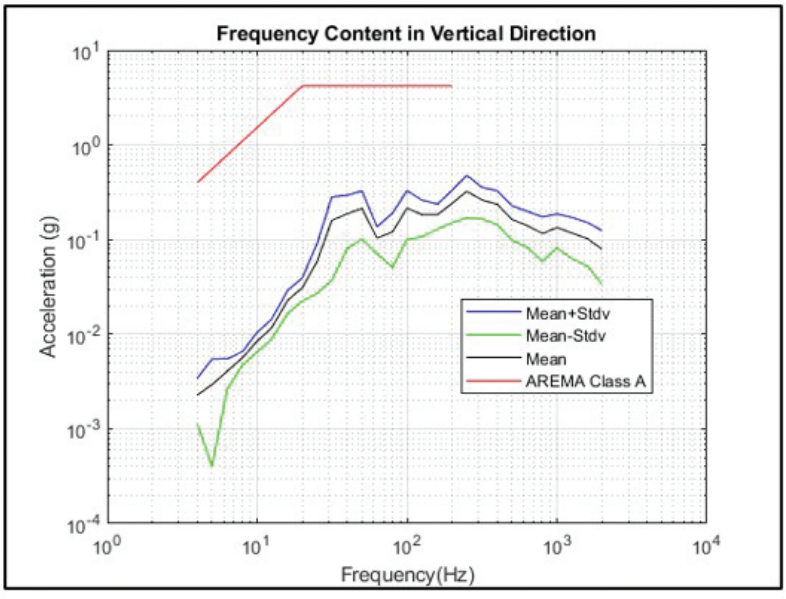
Fig. 5 Measured Vibration Levels at Location – without Rail Corrugation

- To corroborate this, another measurement location was selected along the track where the train can speed up to 35 mph. The measured vibration levels are plotted in Figure 5. As noted, at this location the vibration levels between 700

and 1000 Hz are measured to be 0.4 g compared to a maximum vibration level of 10g where there is significant rail corrugation (Figure 4).

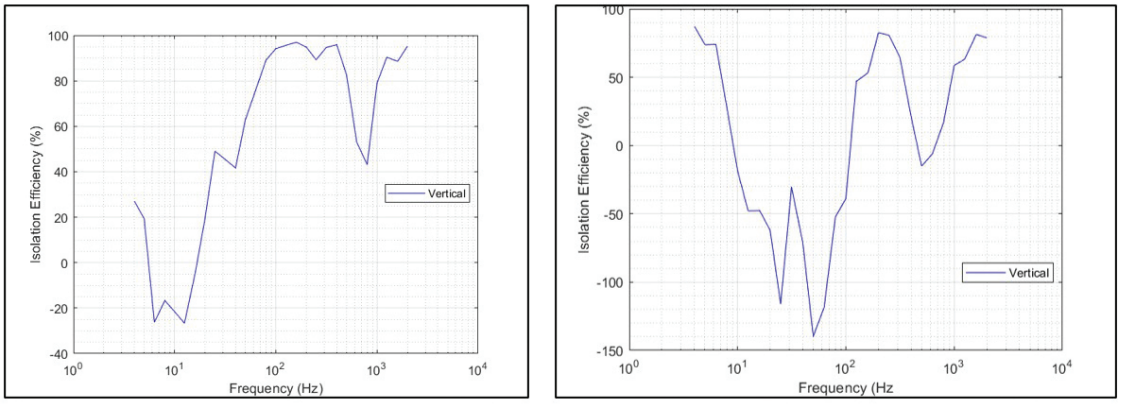
Fig. 7 Comparison of Vibration Isolation Between Wire Rope Isolator and 3/8" Thick Neoprene Isolator

- A typical isolation curve for wire rope isolator and 3/8" thick neoprene isolators are presented in Figure 7. Note that positive values in Figure 7 show effective isolation while negative values indicate amplification of vibration. Based on

the assessment, isolation efficiency in the vertical direction is the governing factor for overall isolation performance, and as such, the details for lateral and longitudinal directions are not included in this paper.

- There is no isolation up to approximately 100 Hz with 3/8" thick neoprene pads. The isolation efficiency is also negative between 300 Hz and 500 Hz indicating that the neoprene configuration is not effective in isolating vibration at these frequencies.
- In the case of wire rope isolators, there is no significant isolation up to approximately 50 Hz. Above 50 Hz, the performance of wire rope isolator is significantly better than 3/8" thick neoprene pads. Overall, the isolation performance of wire rope isolators was significantly better than that of neoprene pads. The vertical isolation efficiency, averaged over different measurement locations is presented in Figure 8.

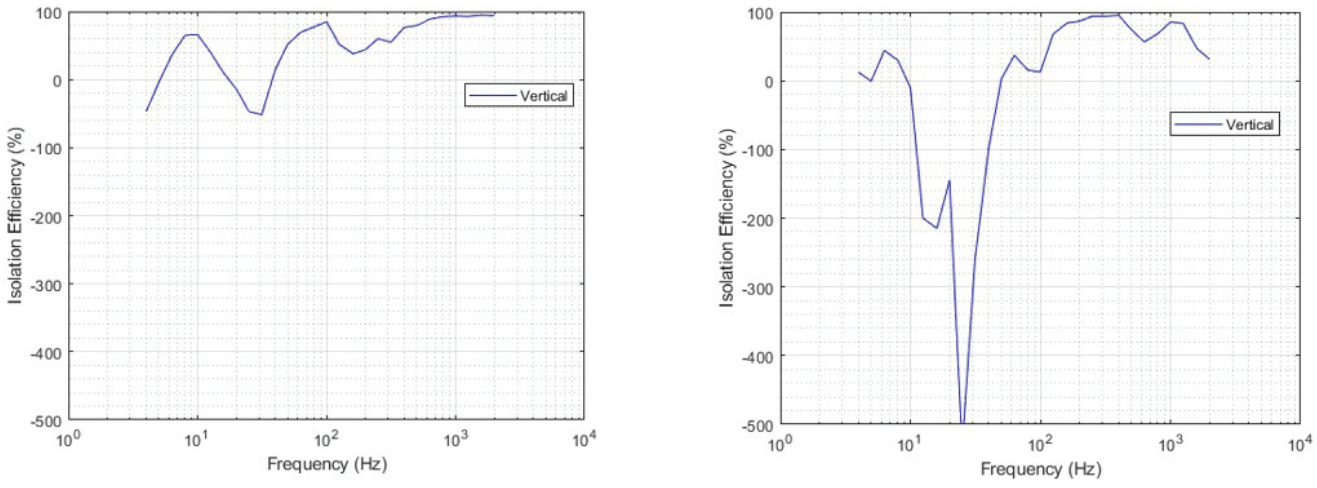
Fig. 9 Typical Isolation Performance with Wire Rope Isolator With and Without Cable

- It should be noted that an additional potential isolation short-circuiting path may be present in the system through the electrical cables that connect the Bonds to the tracks (which can be seen in Figure 1). It was decided to conduct additional measurements at one location to quantify vibration transfer through the electrical cable connection. At this locationn, the measurements were first conducted with the cable connections to the Bonds (typical installation). In the second setup, vibration levels were measured at the Bonds without these cable connections in place.

- Figure 9 provides a comparison of the isolation efficiency of these setups, which confirmed that vibration transfer through the cable connection was minimal. As noted previously, efficiency in the vertical direction governs the isolation design under the operating conditions.

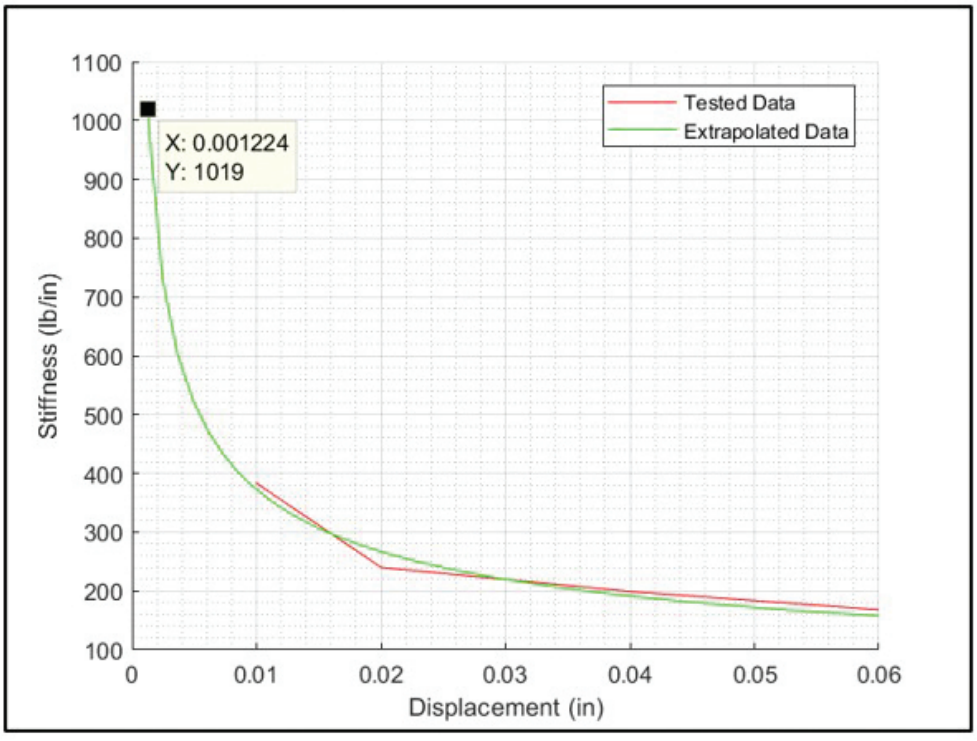
Fig. 10 Stiffness of Wire Rope Isolators Under Operating Conditions

- It was requested that the vendor of the wire rope isolator, provide more information on the load-deflection curve in the region of low amplitude displacement. The data provided was then extrapolated to estimate the stiffness of the wire rope isolator under the operating load regime. See Figure 10.

- Based on the updated stiffness parameter under the operating load regime, the dominant frequency was predicted to be 19.80 Hz. Further, the load distribution of the wire rope isolator was noted to be non-uniform.

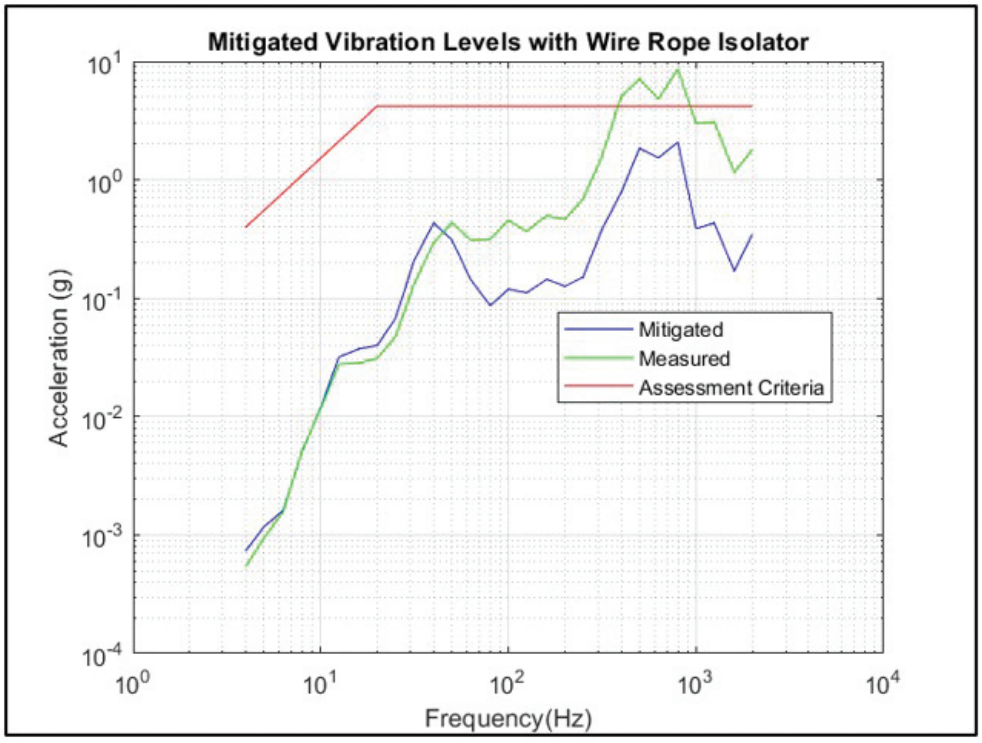
Fig. 12 Predicted Mitigated Vertical Vibration Level using Wire Rope Isolator

Using the isolation efficiency of the wire rope isolator setup, predicted mitigated levels from the measured highest vibration levels were obtained. The predicted mitigated results in the vertical direction are shown in Figure 12.
